June 28, 2019
File No. 262018.063

Subject: Department of Natural Resources Washington Geological Survey,
School Seismic Safety Assessment Project, Contract No. AE 410 -
Seismic Evaluation for **Mount Baker School District**

School Buildings Evaluated in the Mount Baker School District

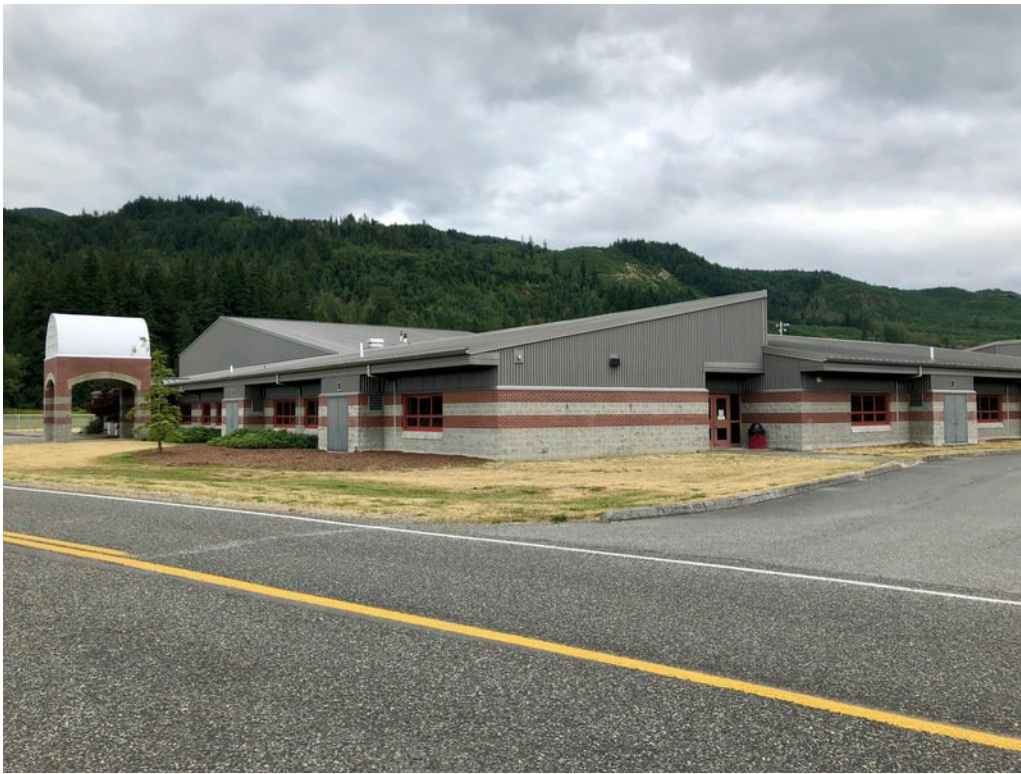
Figure 1-2. Exterior Elevation of the 200 Building from Inside the School

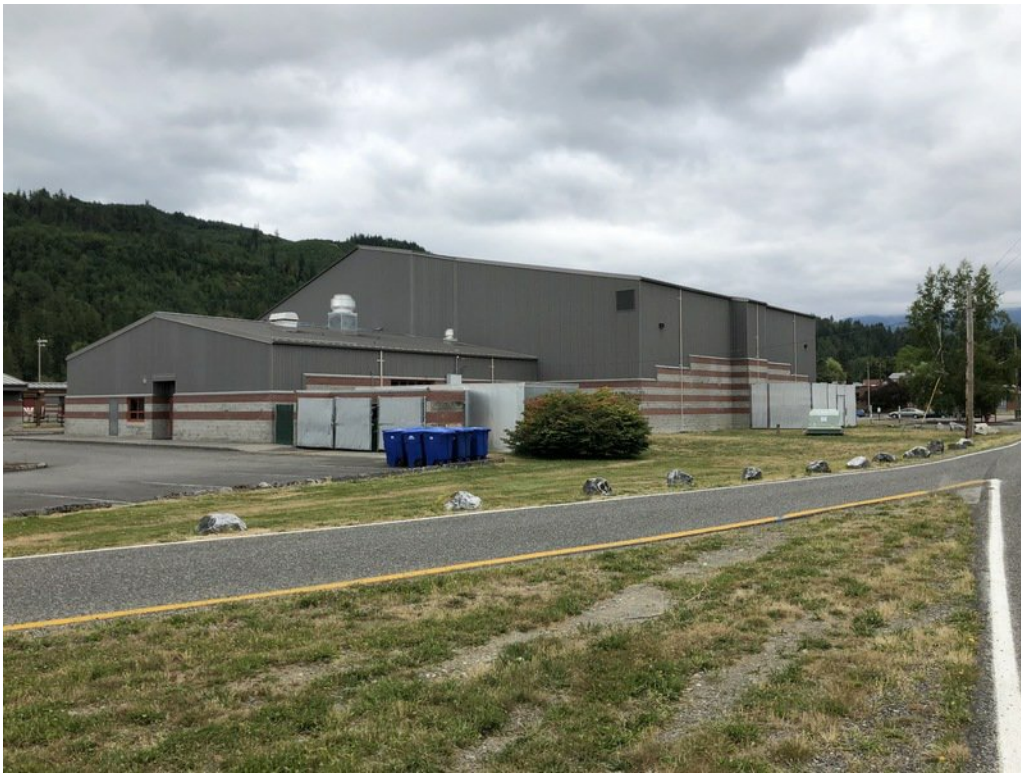
Figure 1-2. Exterior Elevation of Building 100- Pro-Rate Portion of Commons for the Mount Baker JHS from Parking Lot

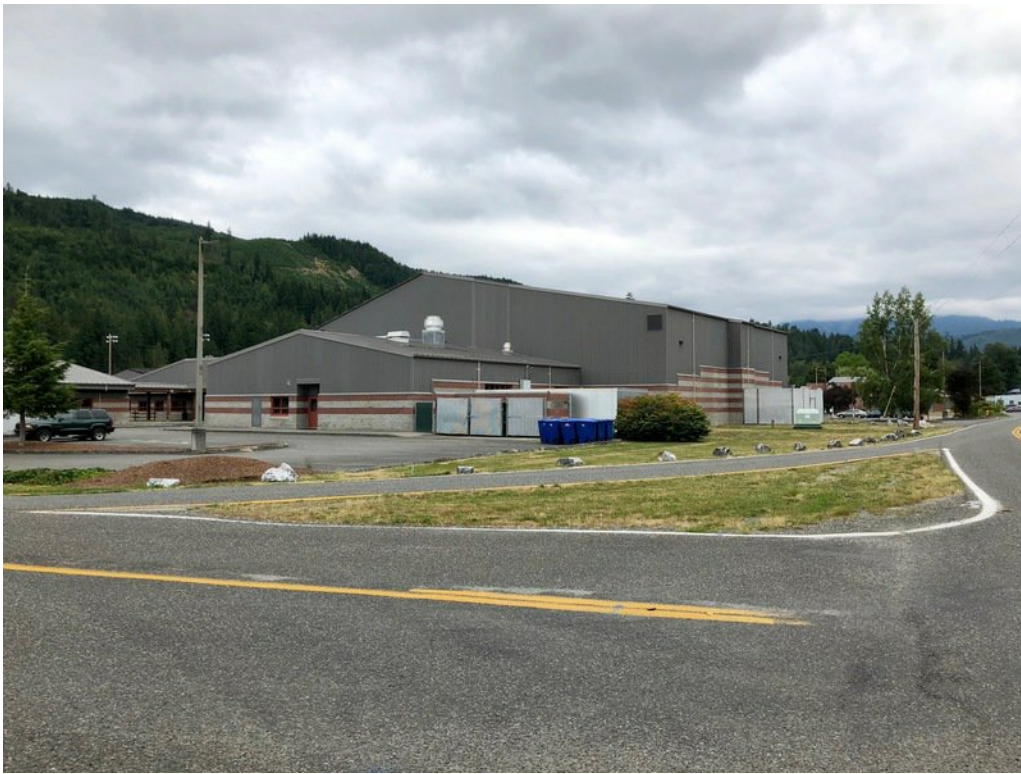
Figure 1-4. Exterior Elevation of the Building 100- Pro-Rate Portion of Commons for the Mount Baker JHS from the Road Side next to the 200 Building

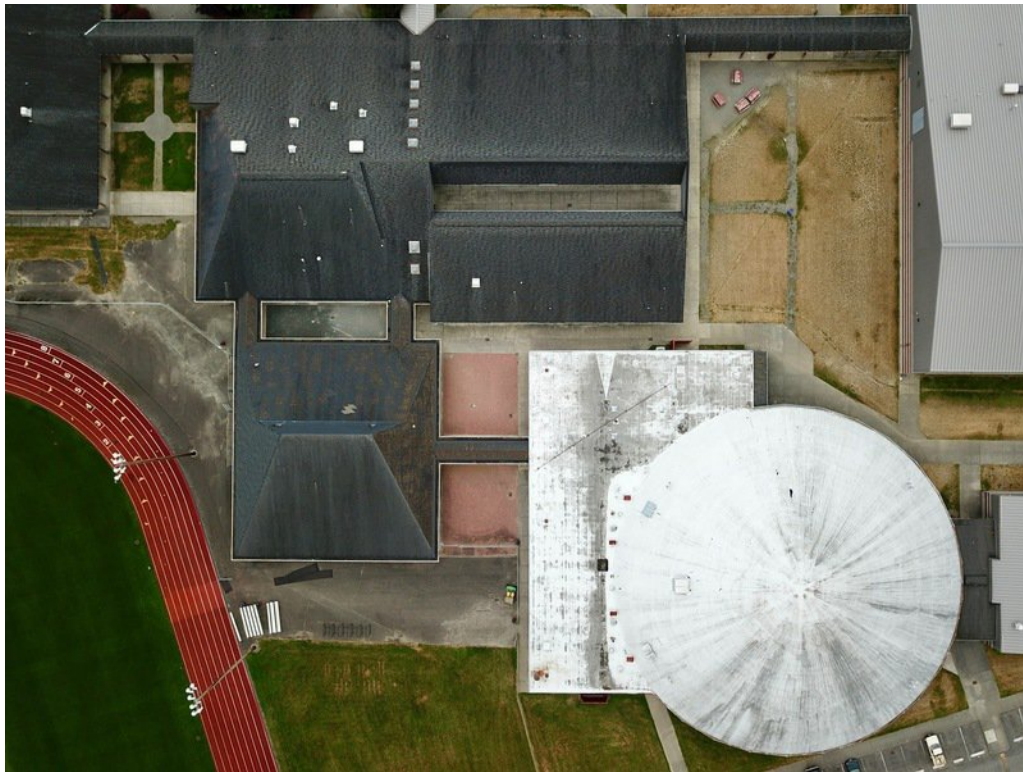
Figure 1-1. Exterior overhead plan of building. See top of photograph.

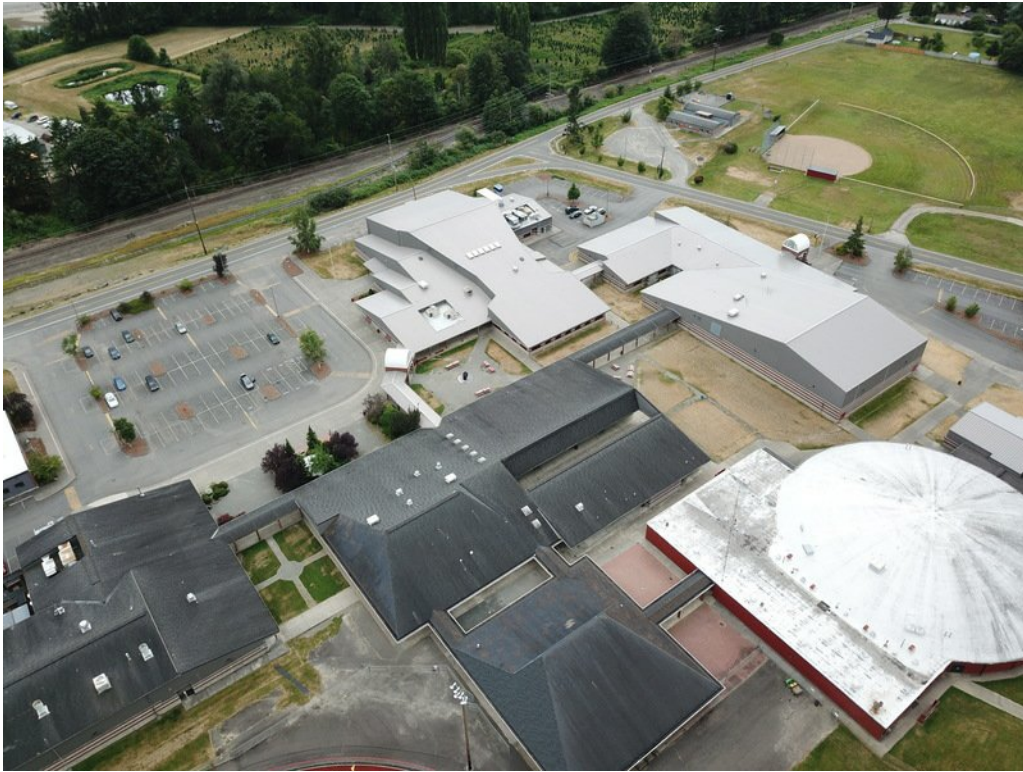
Figure 1-3. Aerial View of 300 North Building. See middle building of the three on the lower portion of the photo.

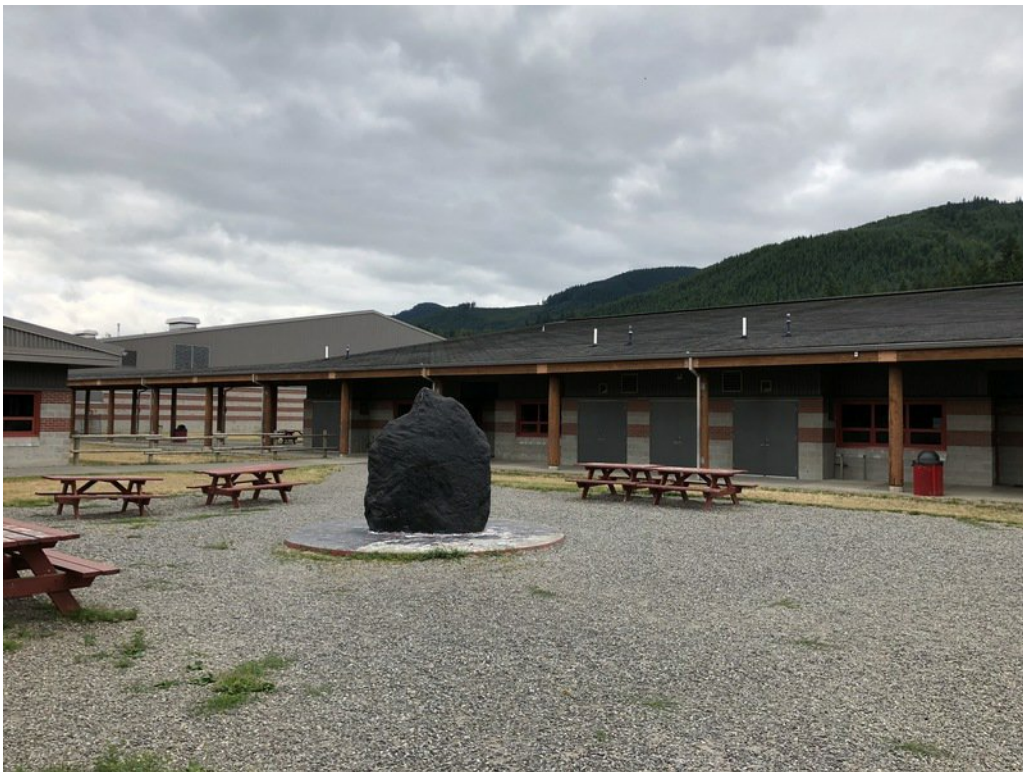
Figure 1-4. Exterior Elevation of 300 North Building from the Quad between the 300 North and 100 Building

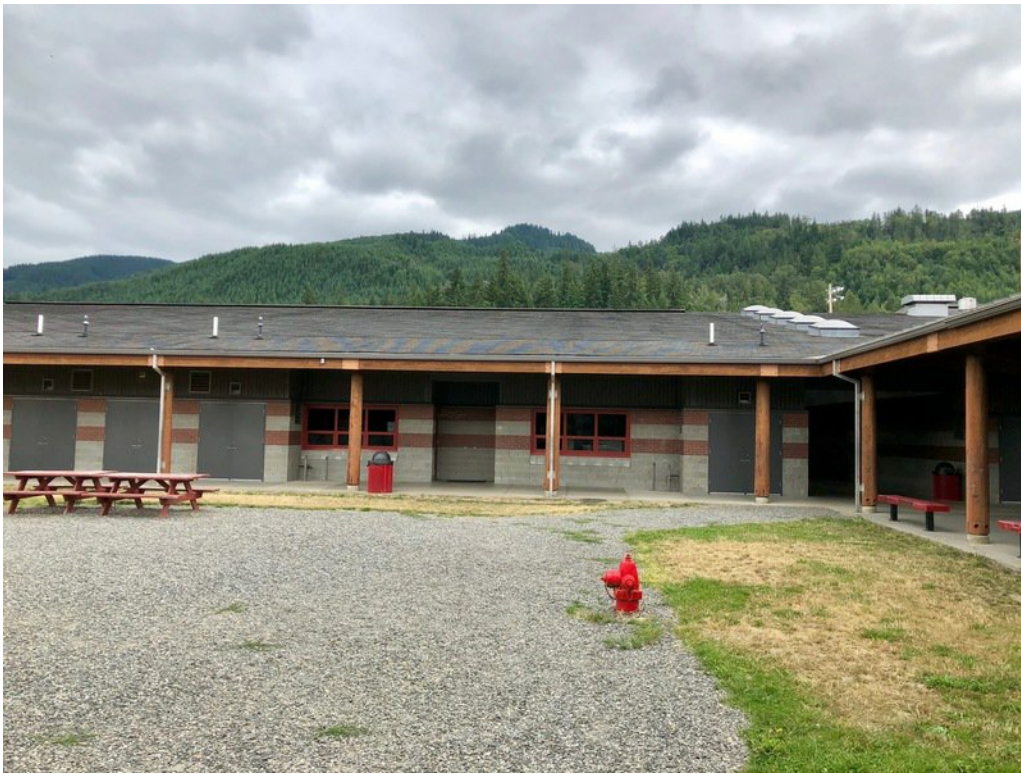
Figure 1-5. Exterior Elevation of 300 North Building from the Quad between the 300 North and 100 Building

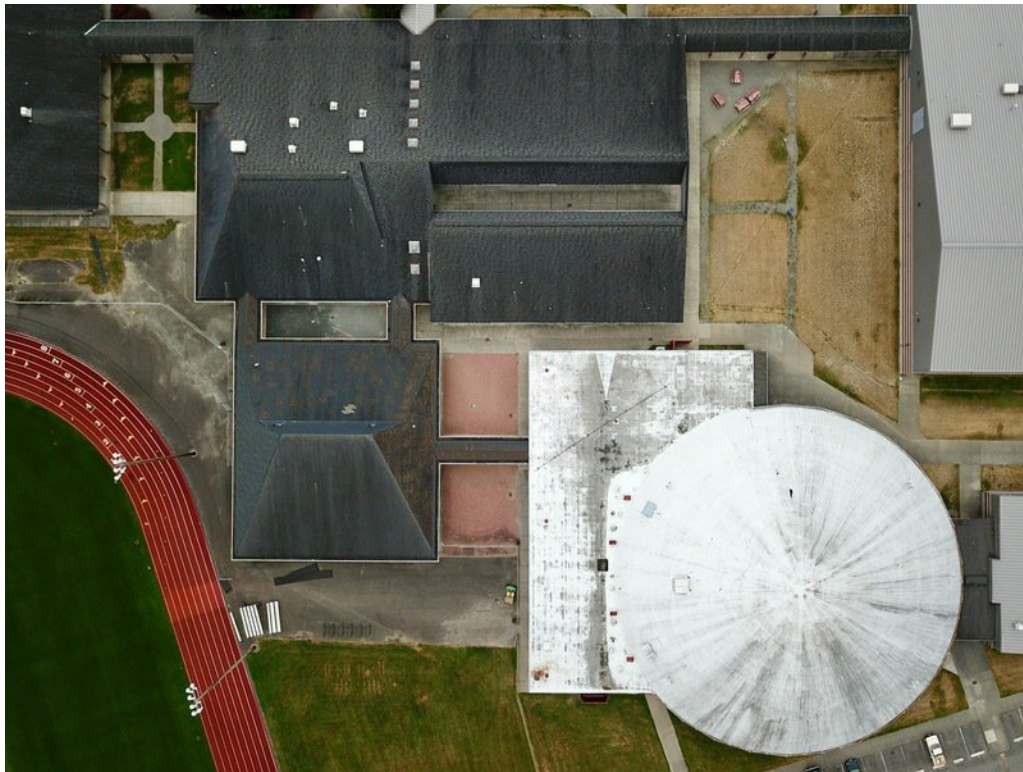
Figure 1-1. Exterior overhead plan of building. See top of photograph.

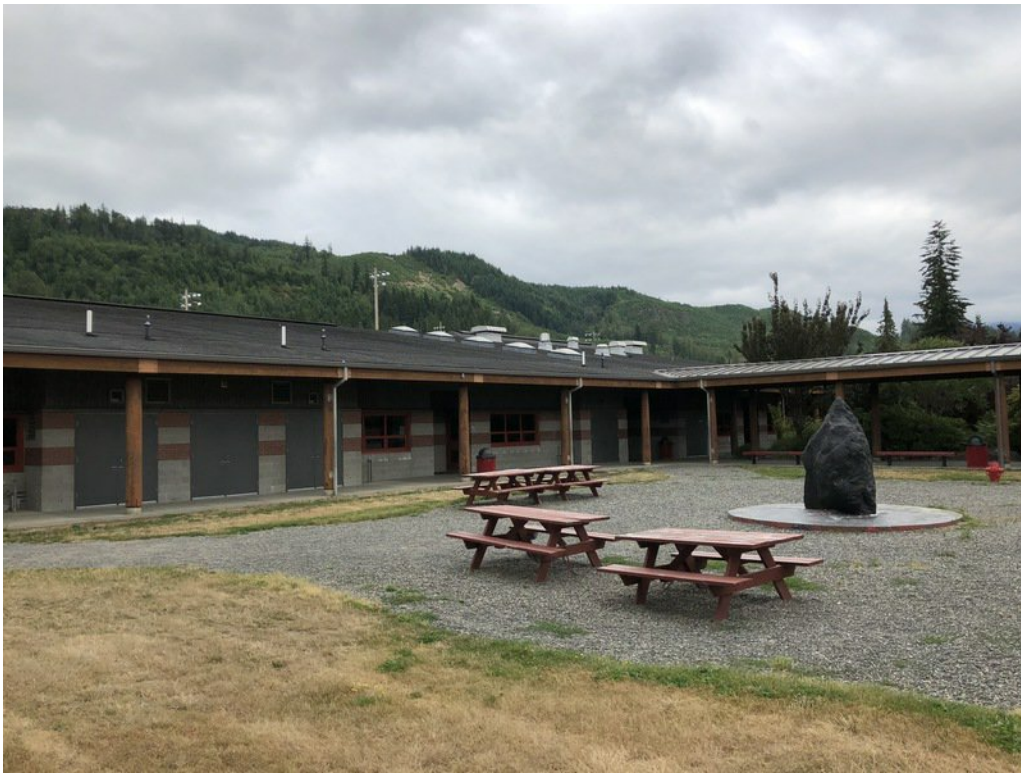
Figure 1-3. Exterior Elevation of 300 South Building from the Quad between the 300 South and 100 Building

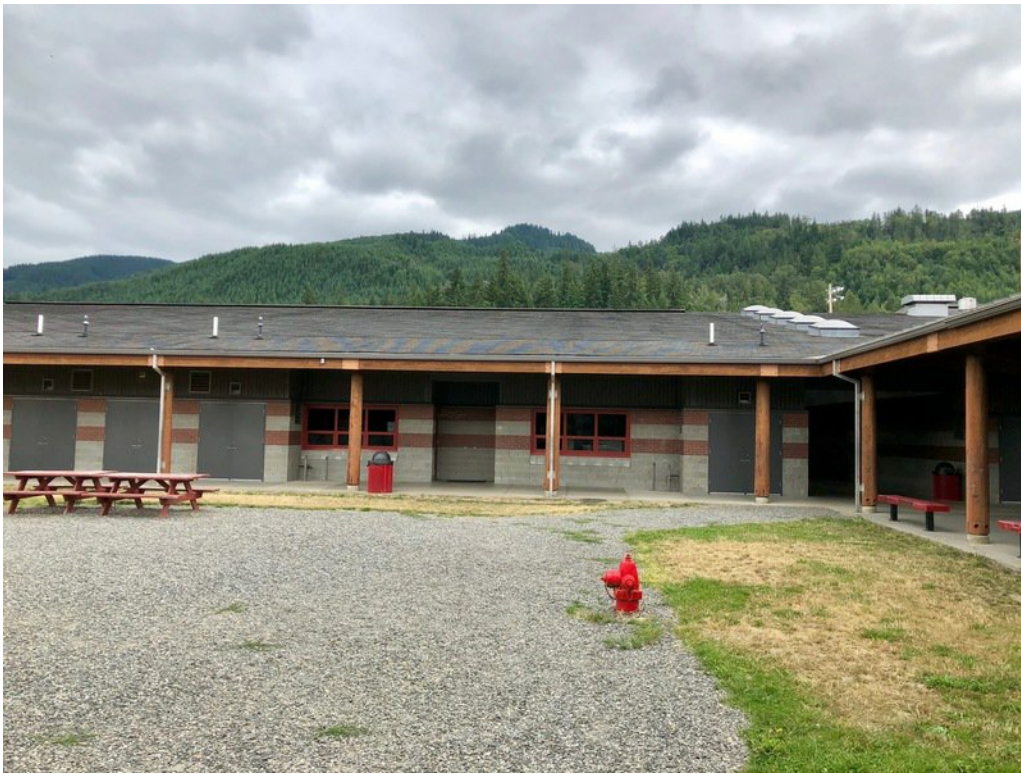
Figure 1-5. Exterior Elevation of 300 South Building from the Quad between the 300 South and 100 Building

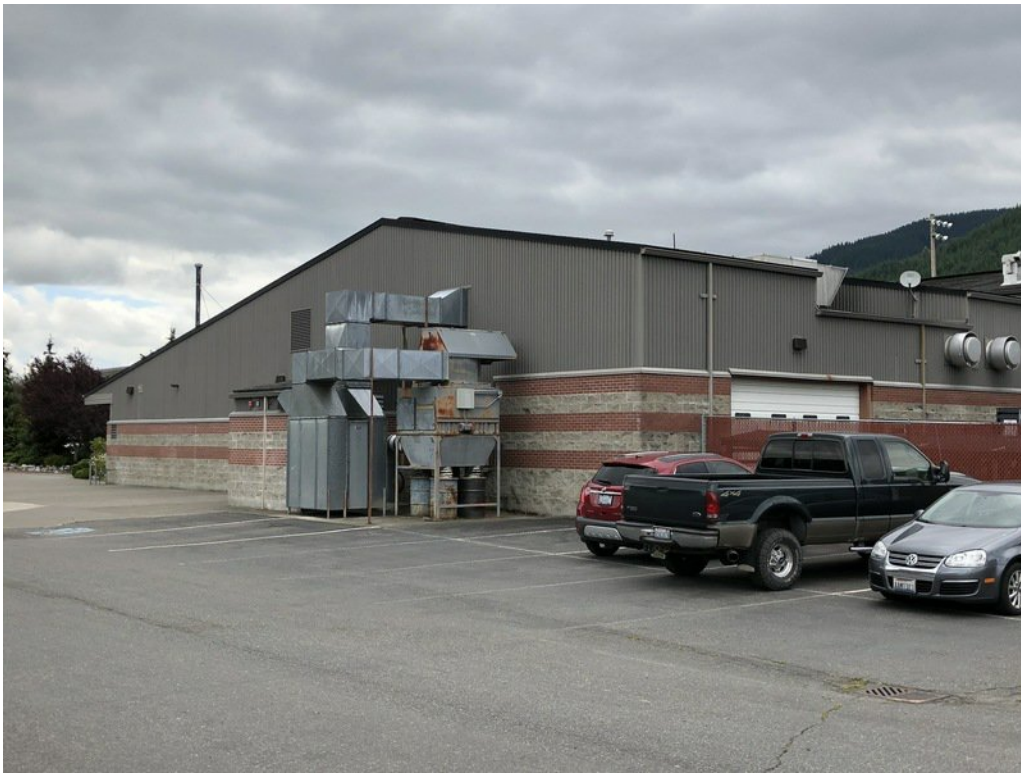
Figure 1-3. Exterior south side of building.

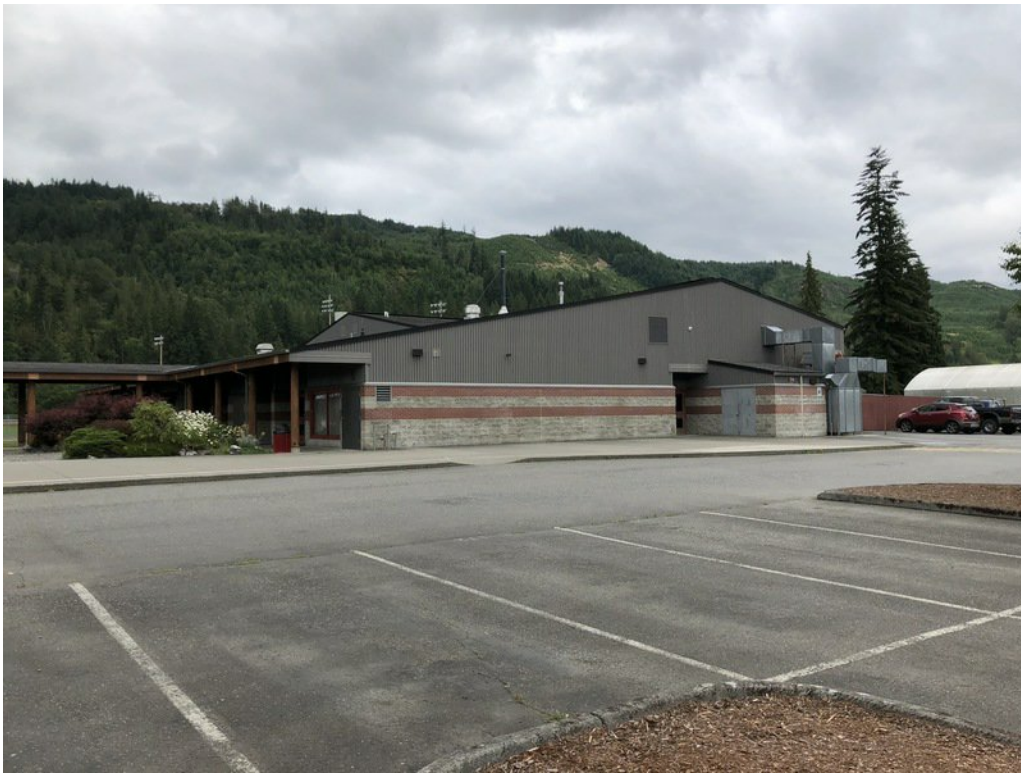
Figure 1-5. Exterior Elevation of 700 Building from the Parking Lot

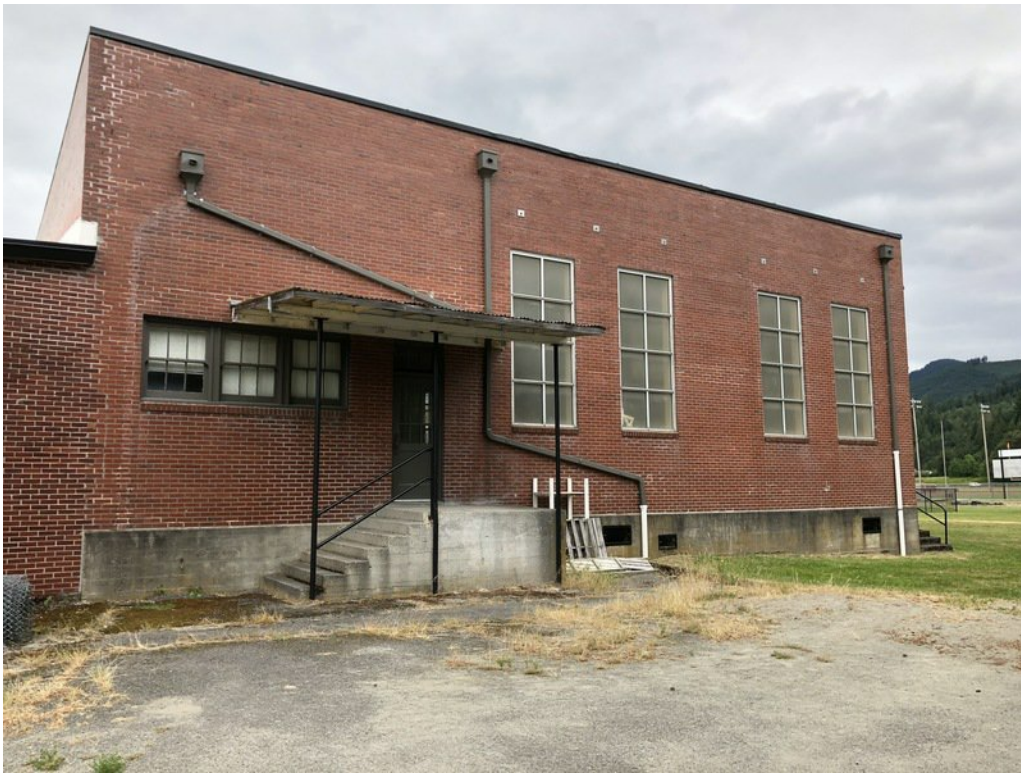
Figure 1-3. Exterior northeast side of building.

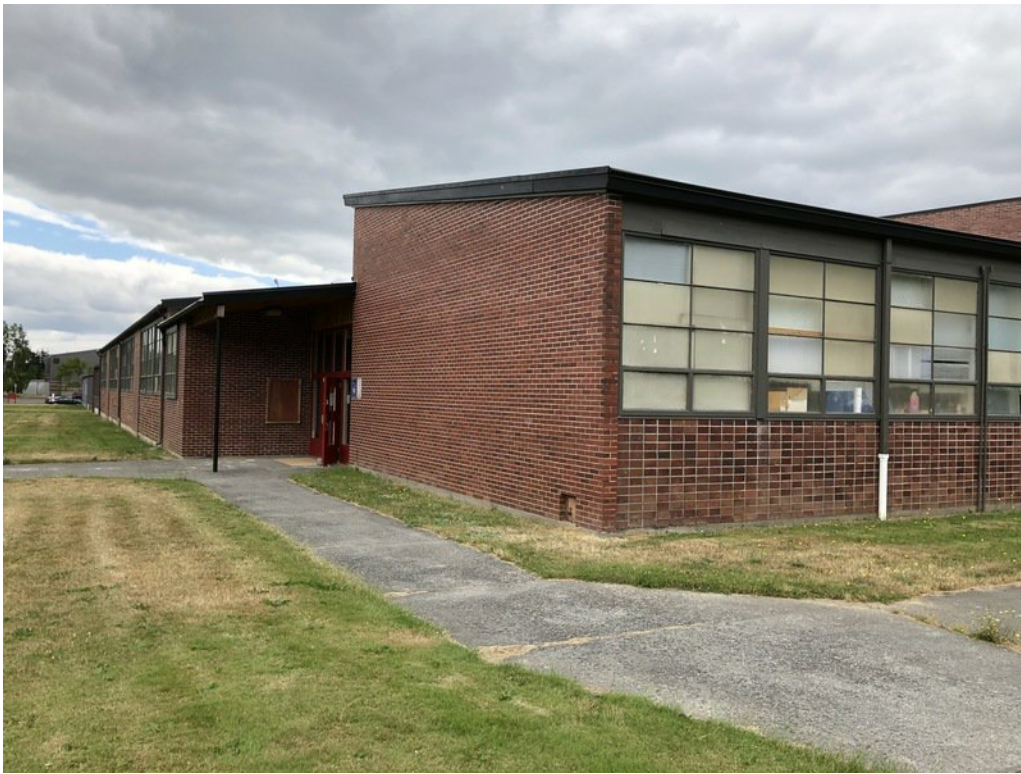
Figure 1-5. Exterior southeast corner of building.

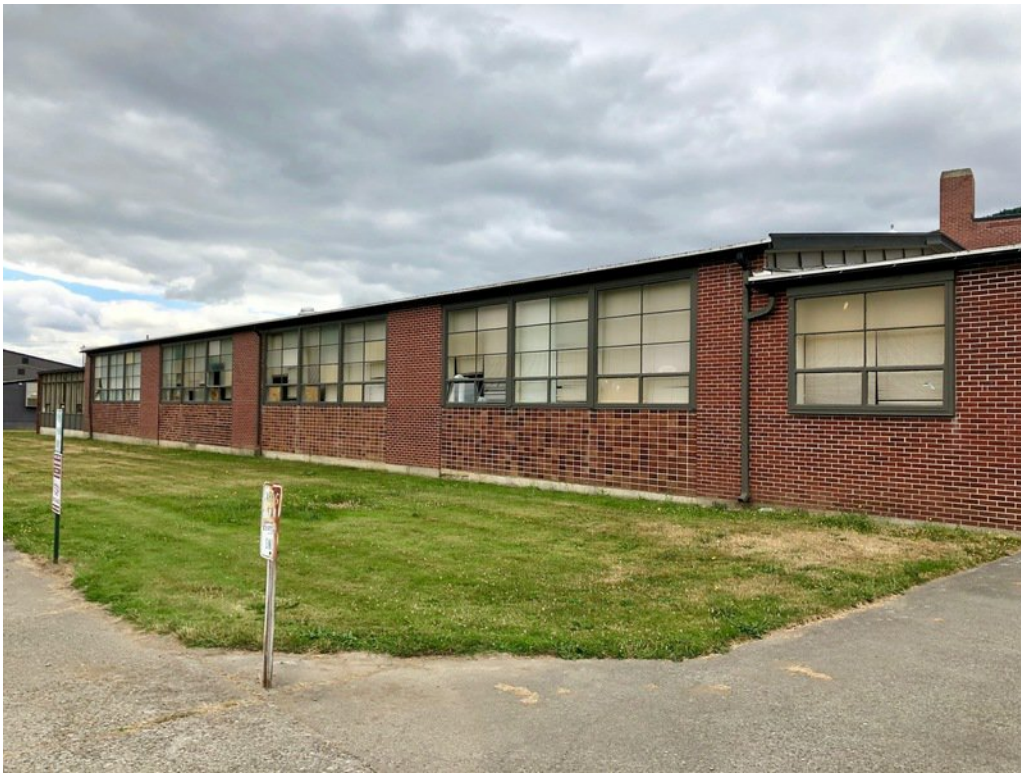
Figure 1-7. Exterior south side of building.

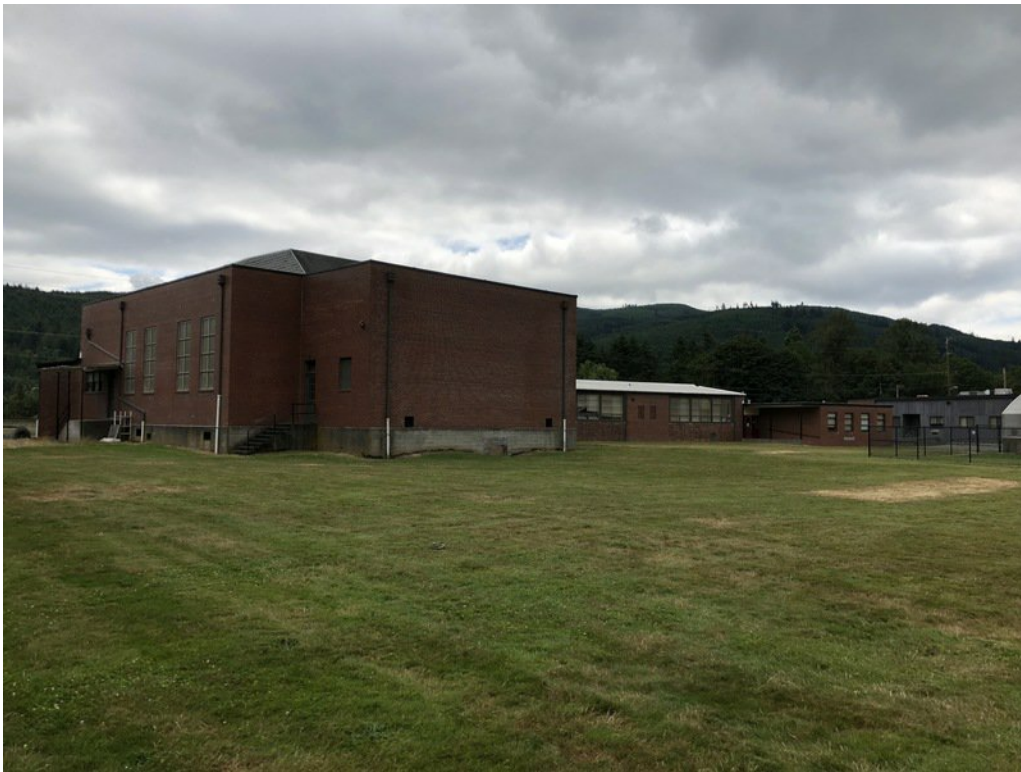
Figure 1-9. Exterior north side of building.

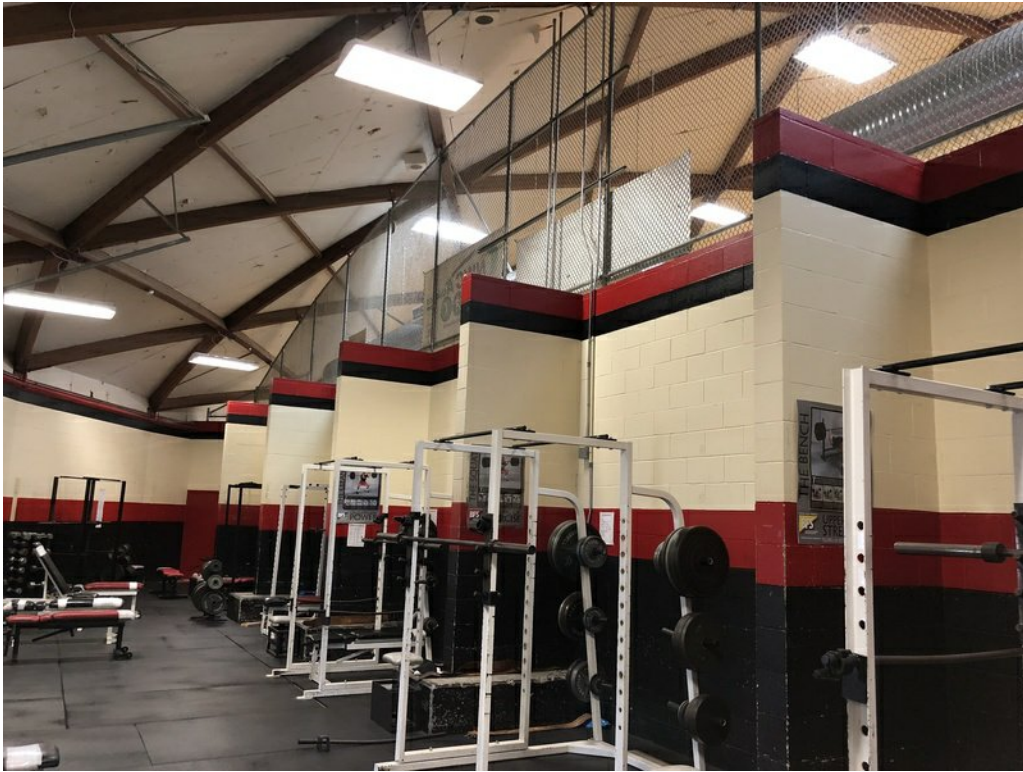
Figure 1-3. Gymnasium interior. Area is partitioned off from the rest of the gymnasium.

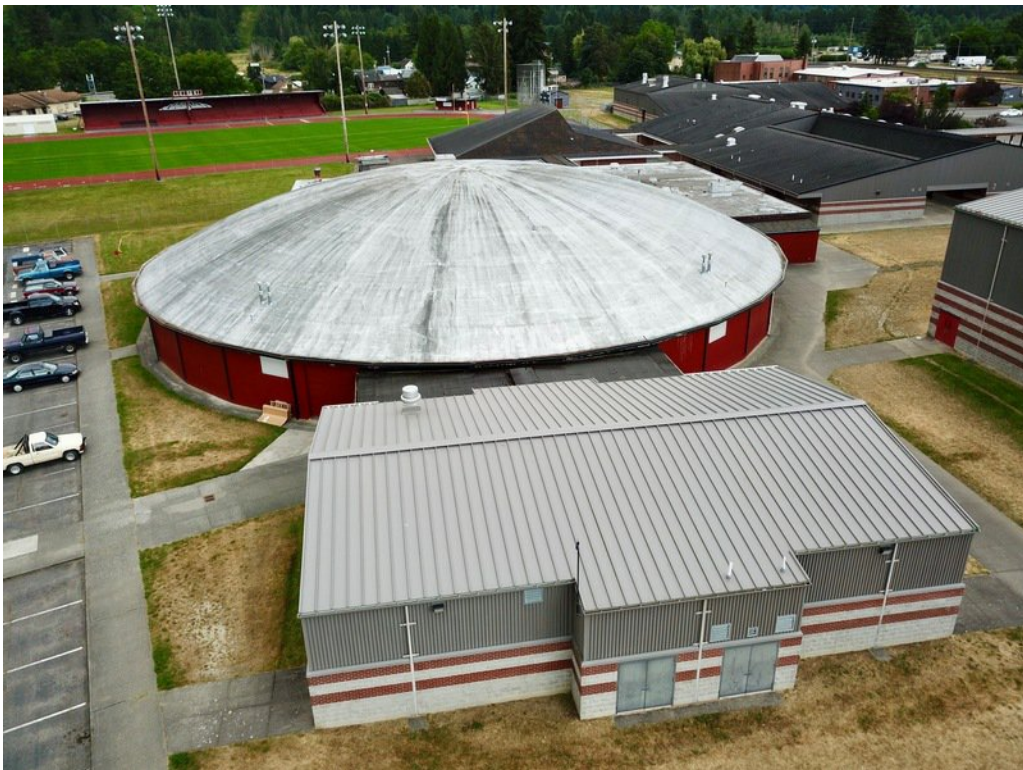
Figure 1-4. Exterior east side of building.

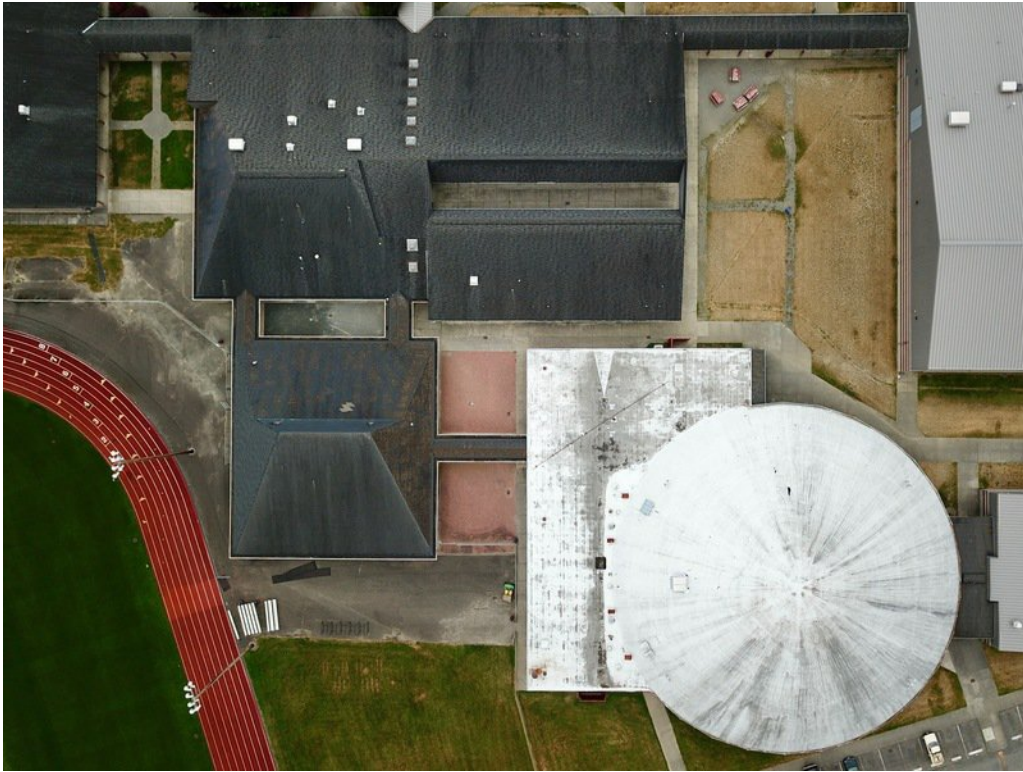
Figure 1-5. Exterior overhead plan of building.

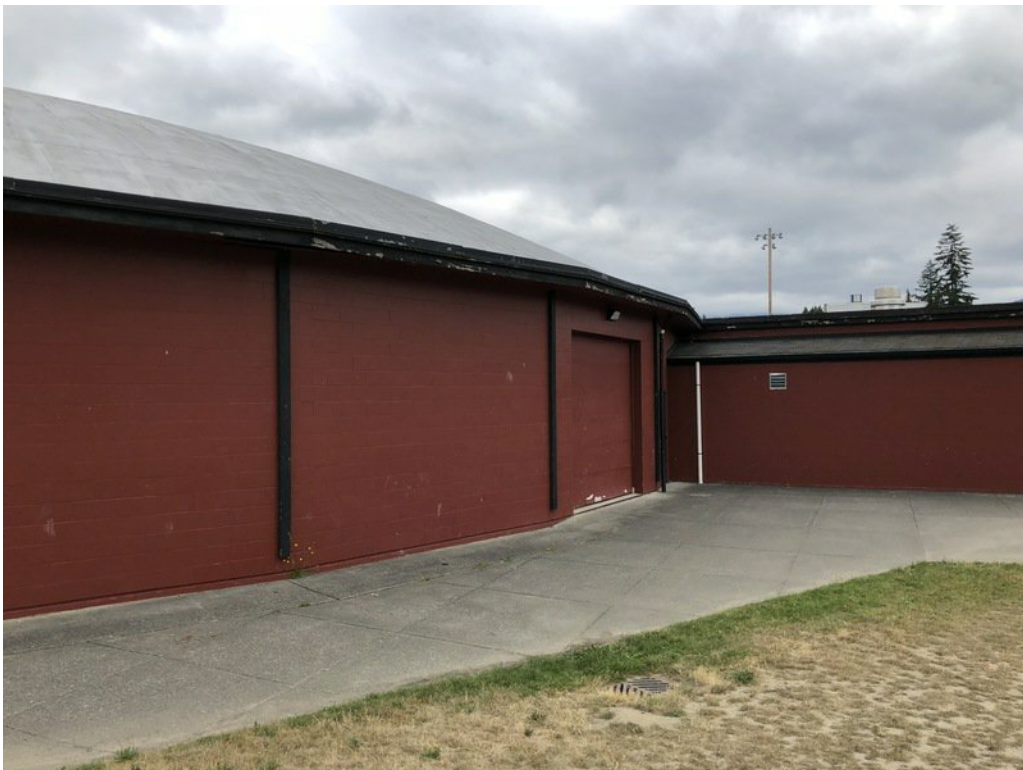
Figure 1-6. Exterior south side of building.

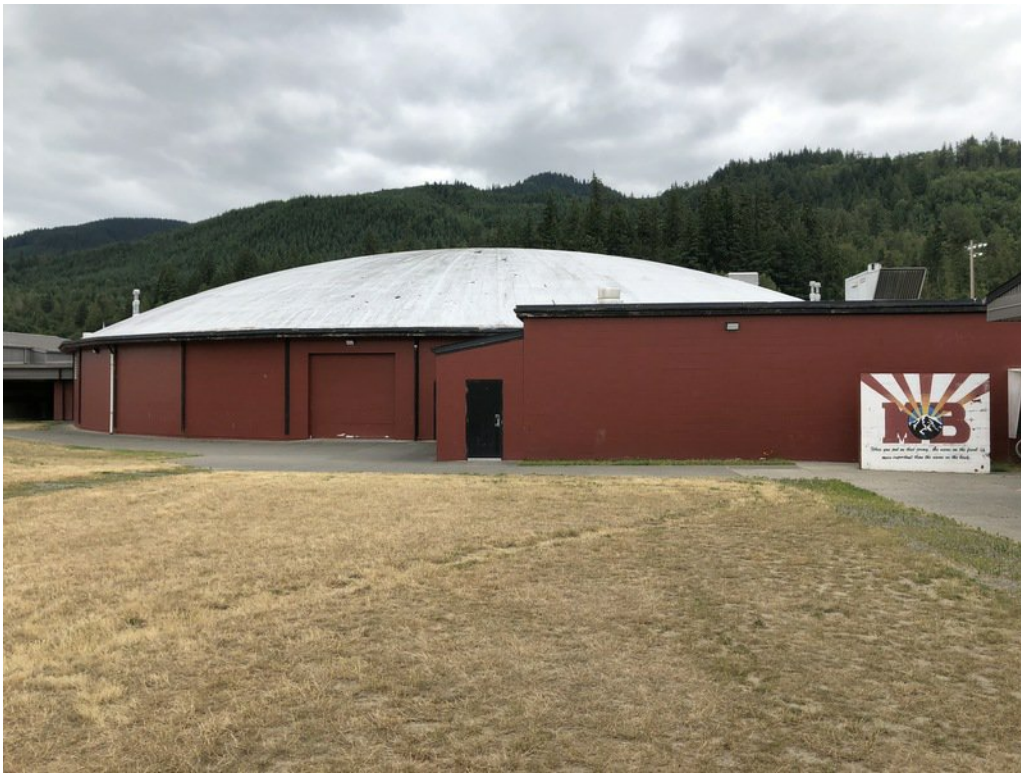
Figure 1-7. Exterior south side of building.

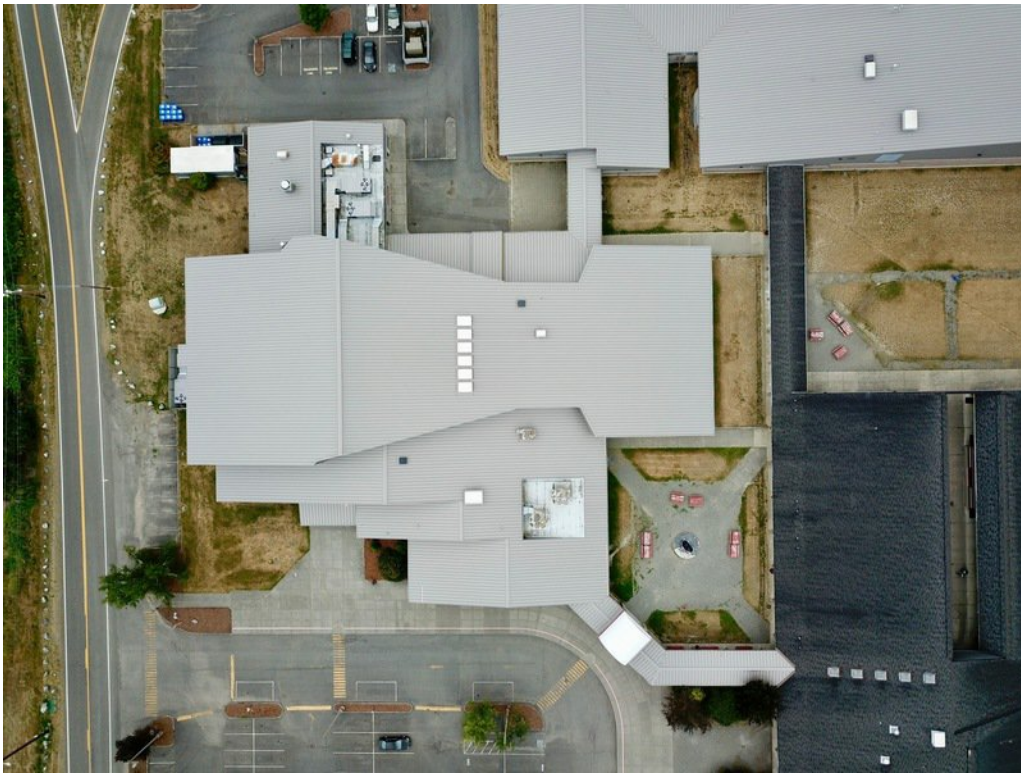
Figure 1-3. Exterior overhead plan of building.

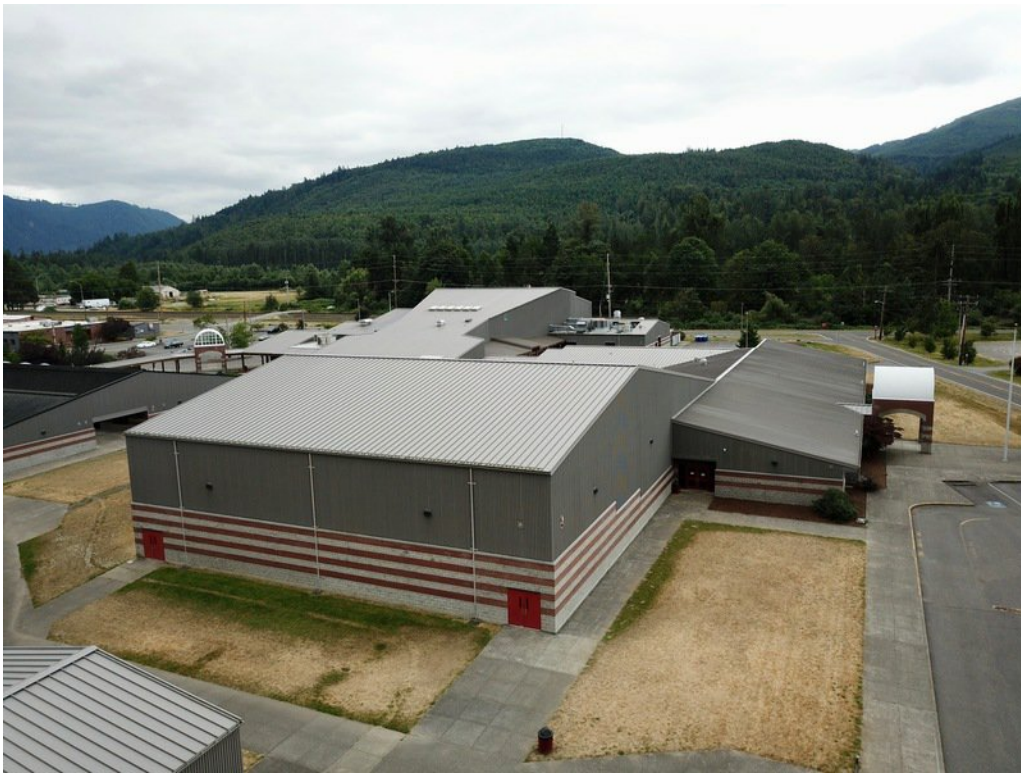
Figure 1-5. Exterior south side of building.
